# Vignale!

ANDARD VANGUARD PHASE III REG # YTM 910

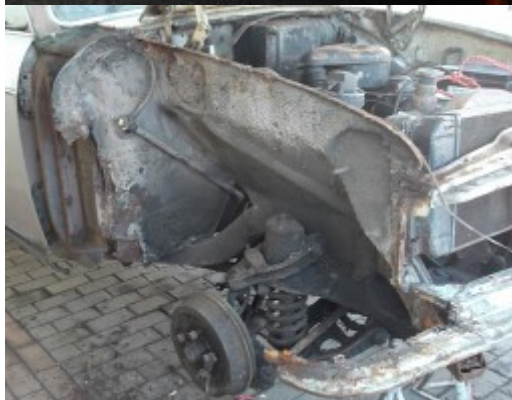
Front o/s wing removed

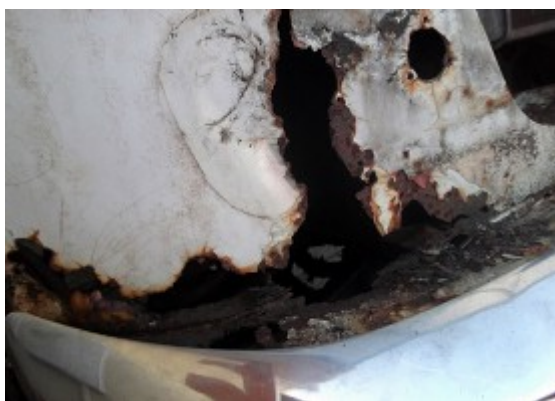
Rust in o/s wing & Valance

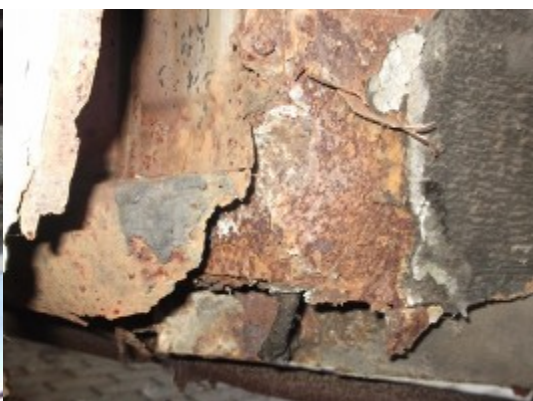
Rust in lower front inner wing

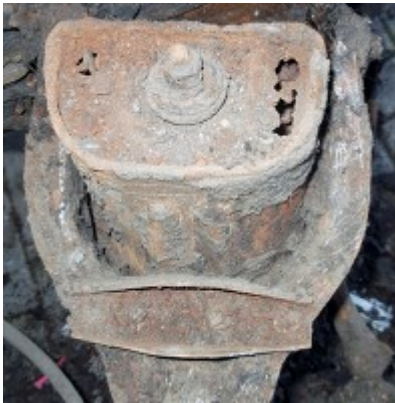
places I found far more corrosion and rot than I had thought possible. There are even large holes in the bulkhead. If I hadn't bought the parts I may have been tempted to scrap the car or sell it on, may have, that is! The front O/S suspension turret is even rotted through!

Rusted through front o/s suspension turret

I cut a piece of 1/8" thick steel plate to the shape of the badly corroded and holed N/S front turret top then drilled a hole in it to accept the shock absorber. The plate was then seam welded in place and then all surfaces were painted with Hammerite black enamel. The bottom trunnion was then fitted to the lower wishbones with the bush nuts (give me a Triumph TR or Spitfire or Herald set up any day! I will have to convert this set up in the future). Using the shims which I had removed the lower wishbone assembly was bolted in place and then the road spring and new shock absorber were installed. I then bolted in place the repaired lower bump stop and the top wishbones again using the original shims. 5.5 hours

The O/S front suspension components were once again cleaned and wire brushed. I then removed the lower trunnion and found that the mills pins were missing and hence the nut bushes had been free to unscrew (they hadn't though). All the parts were then given a coat of black Hammerite enamel. It was then the turn of the suspension turret to have a new plate welded in place so a template was made and the shape transferred onto the thick steel plate. This was then cut with a cutting wheel and filed to fit then the shock absorber hole was marked out and drilled. Before welding it in place I painted all of the surfaces that would be difficult to access after welding. The plate was then seam welded and the turret painted.

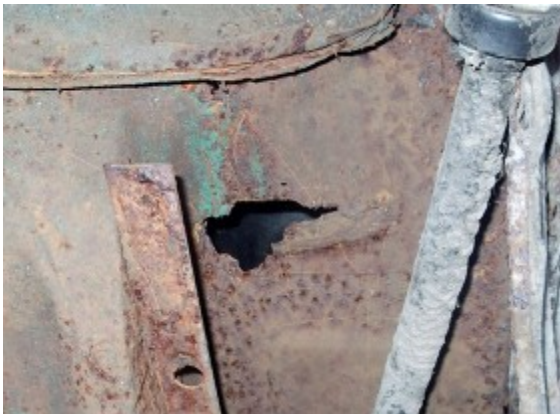
Front o/s inner wing near "A" post rot!

A long day spent cutting, grinding and welding, but at the end I had managed to repair the O/S inner wing where the bonnet attaches with "double skinn" repair patches, the front of the inner wing where the wing attaches, the bottom of the A post/bulkhead and blanked off the front of the O/S sill. I then offered up the front wing and devised a non standard method of bolting the bottom rear of the wing to the car. I then seam sealed and painted all the welds with zinc phosphate red oxide paint.

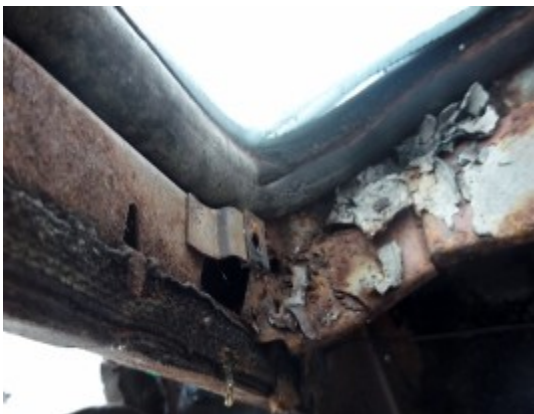
Corroded o/s "A" & Screen frame

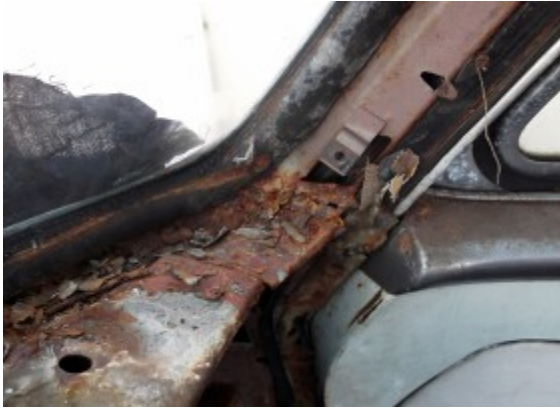
N/S "A" frame & screen frame

corroded

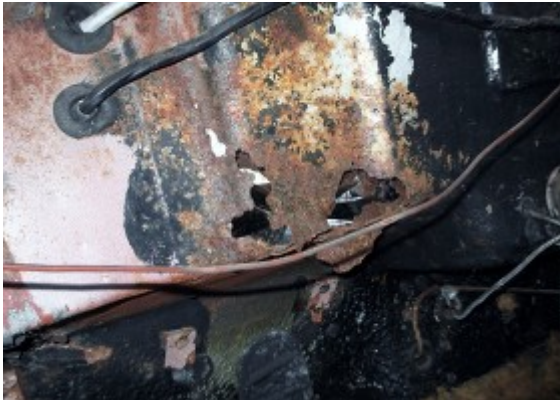
Rotten inner planum wall

Viewed from n/s footwell

Today I made and welded repair patches to the inside of the bulkhead completing the repairs for the inner wall of the plenum chamber. I also made a repair patch complete with drain pipes for the centre of the plenum chamber inside the engine bay. The welds were all ground back, coated with seam sealer and then all repairs were painted with zinc rich primer.

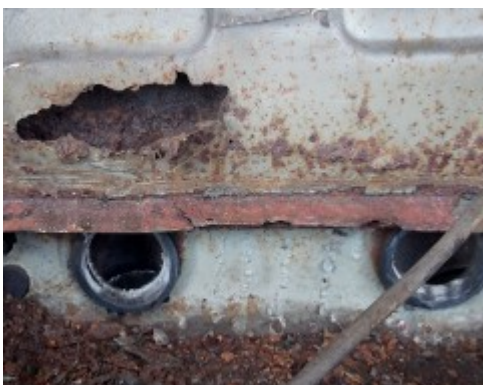
Bulkhead behind heater matrix rotten through

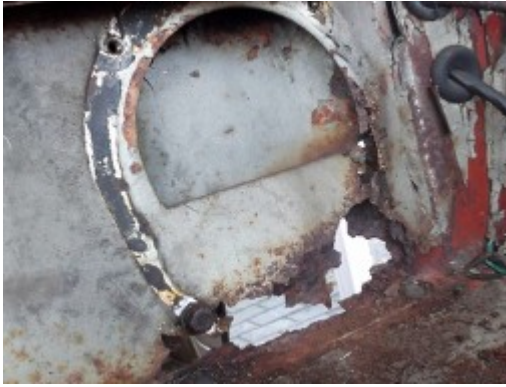
horrendous corrosion with both sides of the plenum chamber rotten through, is the car saveable? I don't know!

Corrosion right through both sides of plenum chamber

Today I cut out as much rot as I could from both sides of the plenum chamber. I then painted all areas with Jenolite rust converter then gave all the areas a coat of zinc rich primer. I managed to remove the top cover of the plenum chamber and rust treated the inside of the top of the plenum chamber/ wiper nut box locating areas after I had removed the wiper rack and nut boxes. I then started to cut out cardboard templates for the many patches that are needed to repair the bulkhead. At this point I was still very dubious about being able to save the car.

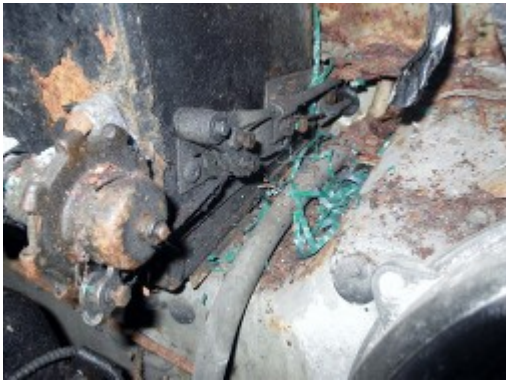
Heater cable setup & holed  
bulkhead

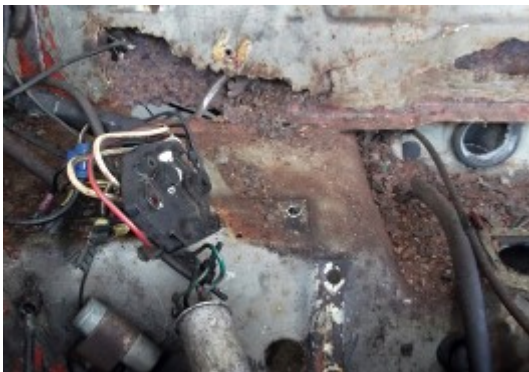
O/S plenum chamber rotted through the 2 walls

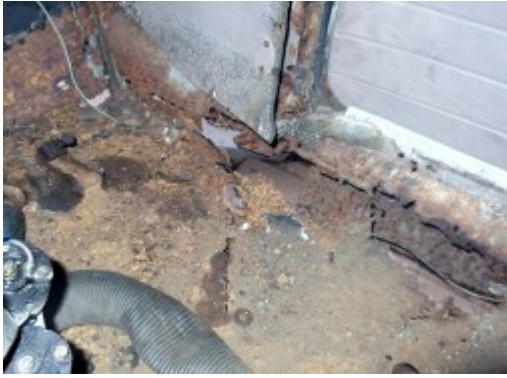
Drivers side floorpan

I patched up the driver foot pan using 2 steel patches seam welded in place, this took quite a while as one of the patches was large and quite an intricate shape. I welded the larger patch to the repaired chassis leg by drilling holes in the it and plug welding it from inside the car. As I couldn't remove the remnants of the accelerator pedal bracket from the floor pan I cut around it with my angle grinder then made up another repair patch and seam welded it in place. Next I turned my attention to finishing off the plenum chamber from the engine bay side. First of all I drilled a 15mm hole at the bottom of the chamber and using Araldite I fixed a piece of copper pipe into the hole to act as a larger drain than the 2 I had made previously. I then made a repair patch for the area of the plenum chamber where the heater connecting flange fits marking out the hole positions carefully then welding nuts to the back of the patch before seam welding it in place. With a bit of time left I turned my attention to cleaning the surface rust from the seal bracket that runs nearly the width of the engine bay above the plenum chamber and then treating it with rust converter. I then remembered that I had to make another repair to the front lower section of the front O/S sub frame,

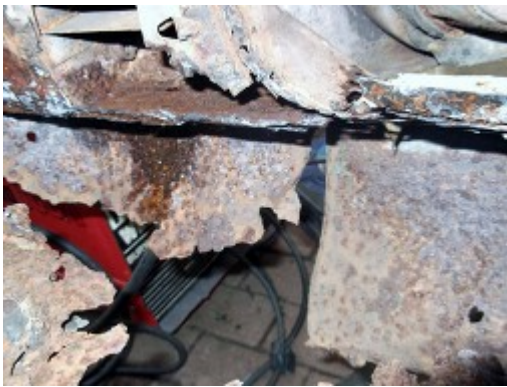
Front of inner sill cut out

I started repairing the front inner sill with 2 patches; I then found that there should be a strengthener inside the sill which had rotted out completely the entire length leaving just ¼" still attached to the top of the sill cavity! I made a 21" long piece and welded it between the new inner sill repair patches and the outer sill to get some strength in that area. I then welded one of the patches I had previously to the inside of the bulkhead. Another disheartening day finding far more welding repairs to do, I should have scrapped it!

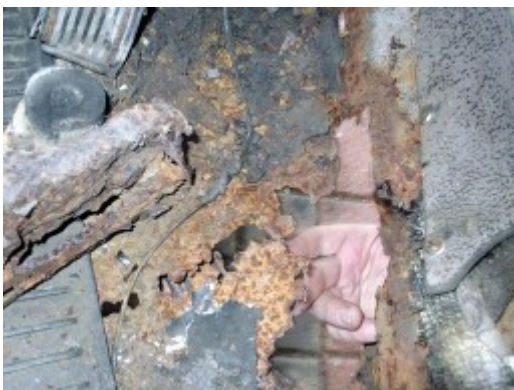
Hole in drivers footwell

Hole in drivers floorpan

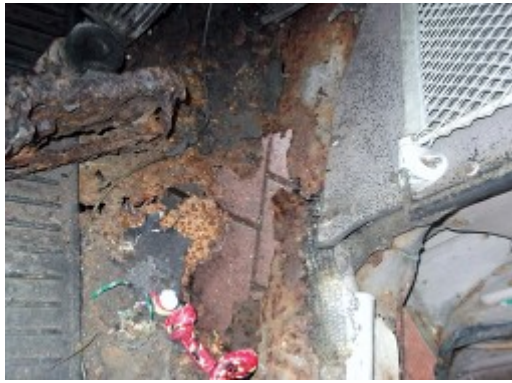
Inner sill made from sheet steel & welded inplace

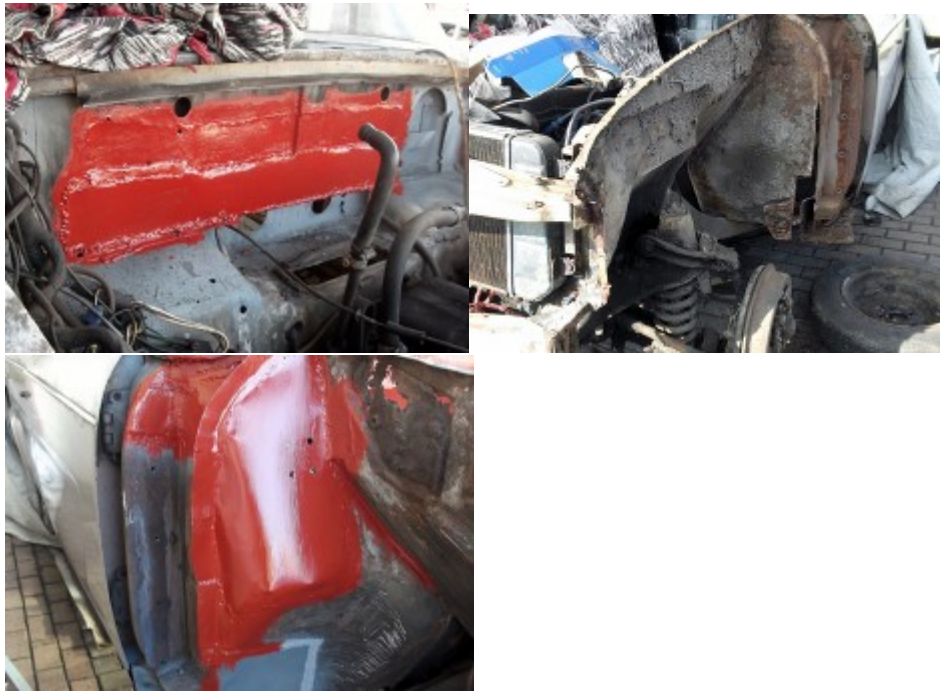
Engine bay plenum chamber welded

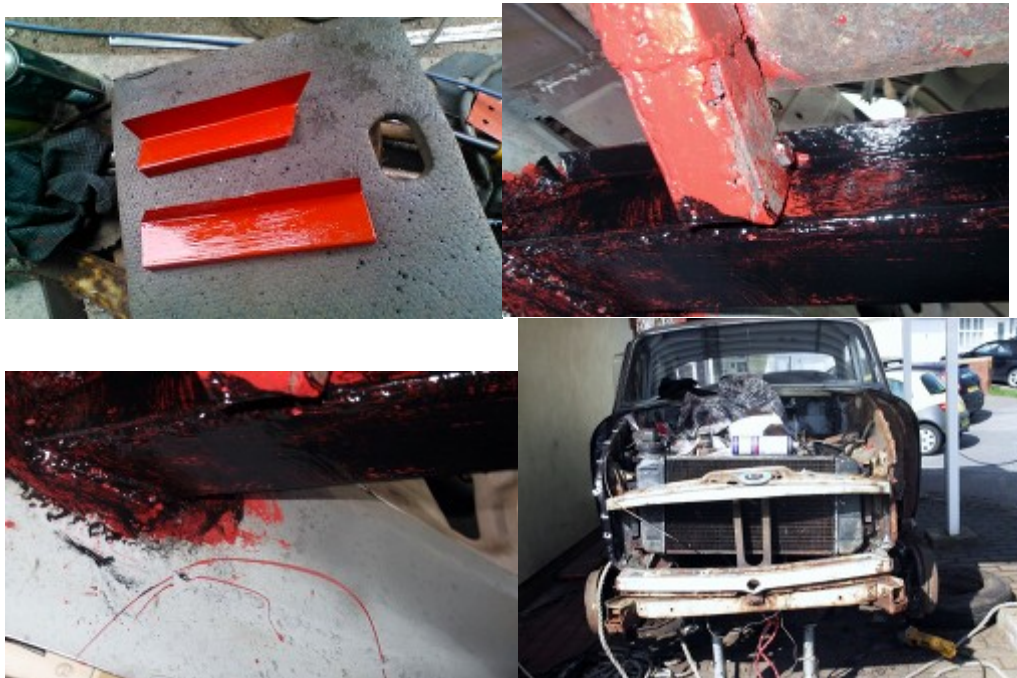
Repaired front O/S chassis leg bolted to sub frame

## **Repaired O/S chassis leg welded in place**

I made a new chassis leg end by forming 2 pieces of sheet steel (9" long) and welding them together. This was then welded into place so that the chassis leg was fully repaired and once more joined to the inner sill. I then cut away the corroded areas of the rear and bottom of the sub frame and welded in repair patches. Working from inside the car which was made easy as there was no floor in this area I cut a slot in the chassis leg to line up with the end of the sub frame. Next I made up a spacer  $\frac{3}{4}$ " square hollow section bar to fit into the sub frame and passed a new bolt through the original mounting holes to hold it in place, this was then welded into the sub frame. Another piece of  $\frac{3}{4}$ " hollow section was then welded to the spacer and also into the chassis leg making a stronger than original joint.

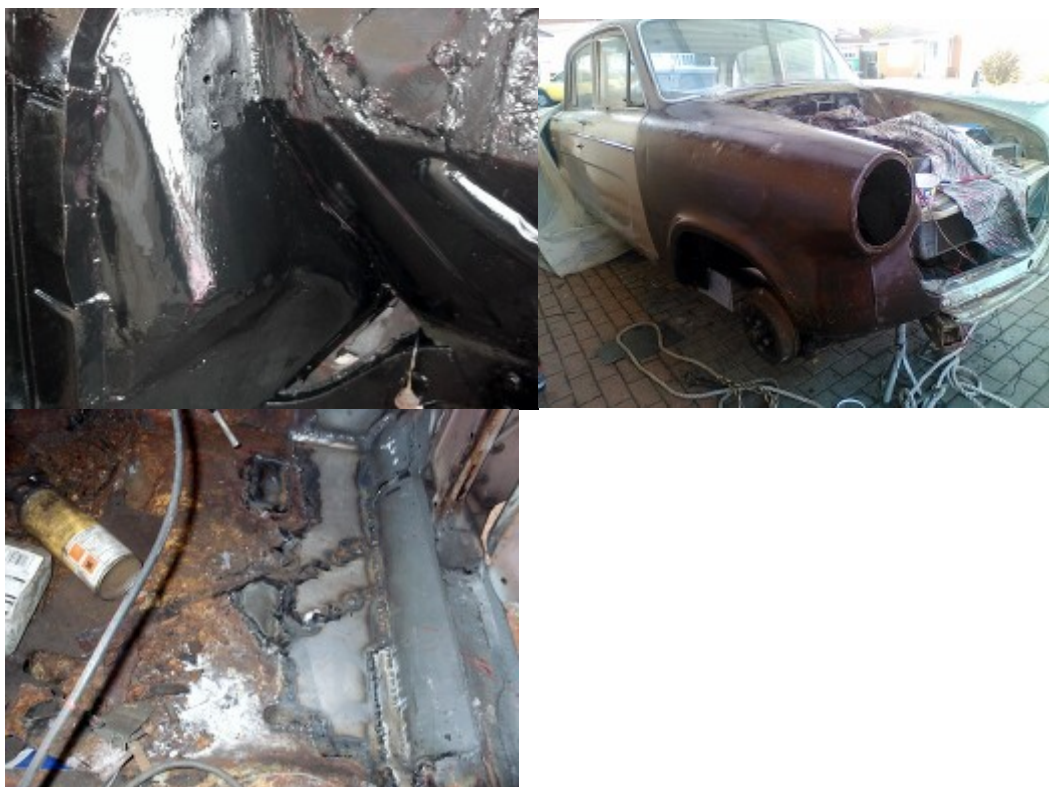
Drivers footwell & accellerator bracket  
area repaired

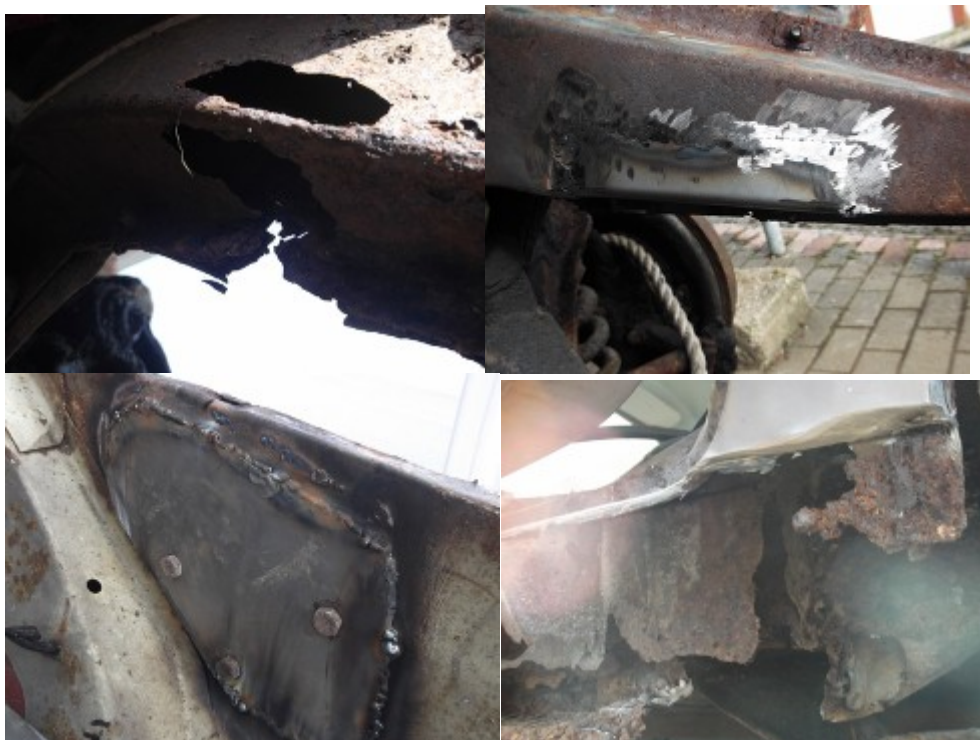
Front n/s chassis leg rotten

Front n/s chassis leg repaired

With only about 3 hours available I thought I decided to try to make up new chassis repair sections for the end of the N/S chassis leg along with a copy of the fixing method for joining the front sub frame to it. I managed to do this and also had enough time to repair the front passenger footwell. After the welds were ground back all bare metal faces were painted with zinc phosphate paint.

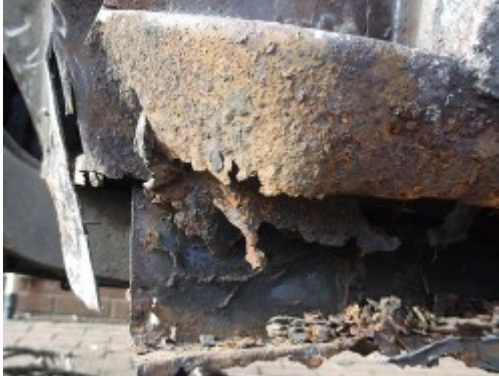
N/S front sill before starting repairs

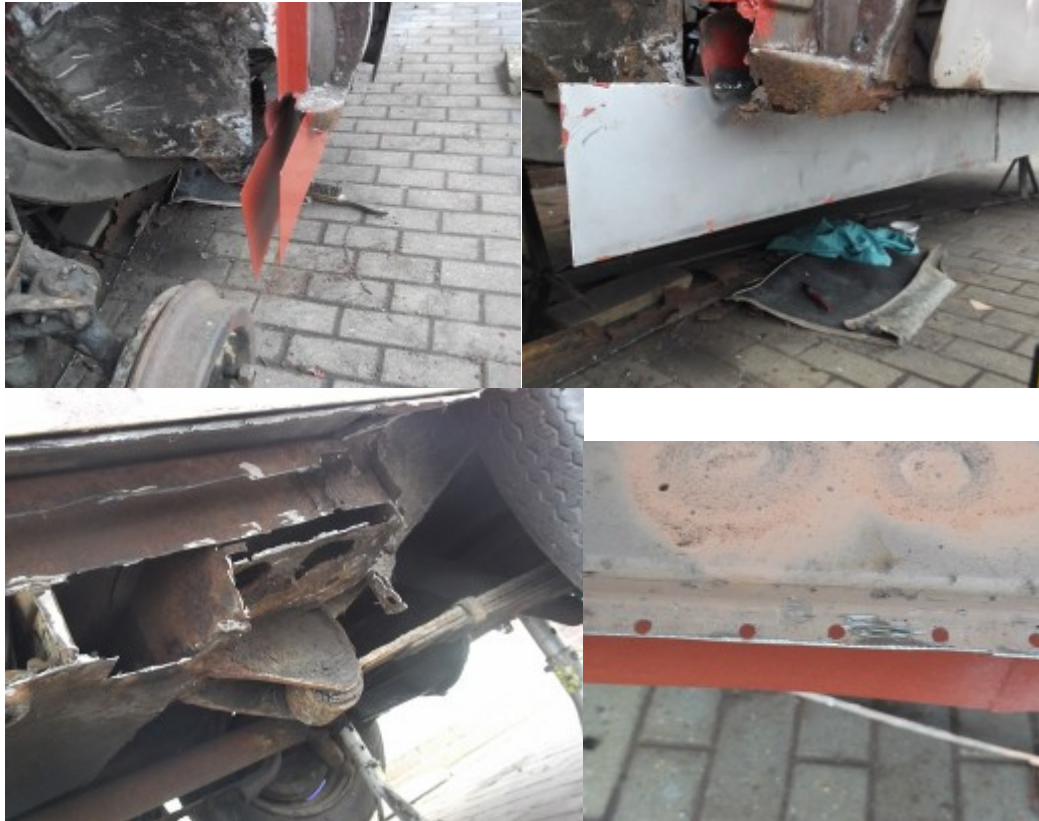
Front of n/s inner sill welded to outer sill

Complex structure of sill

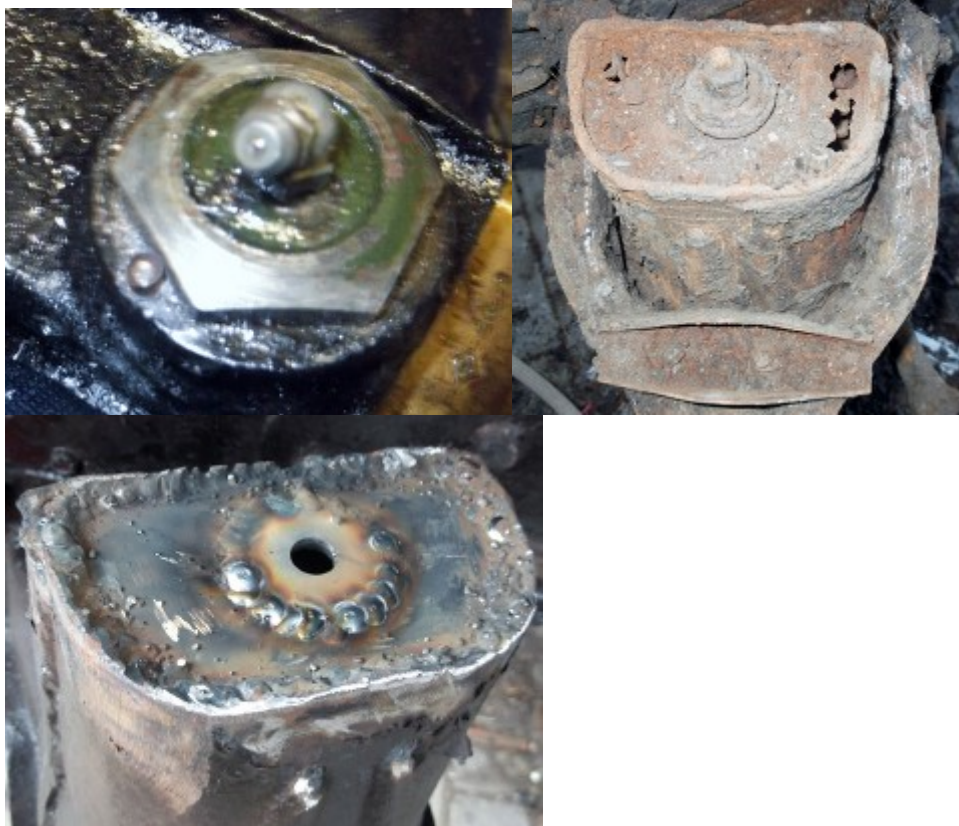
Rear suspension Turret repaired

Rusted through front O/S suspension Turret
